2021 Data Report for

Horsehead Lake, Mecosta County

Site ID: 540085

Horsehead Lake, Mecosta County 2021 CLMP Results

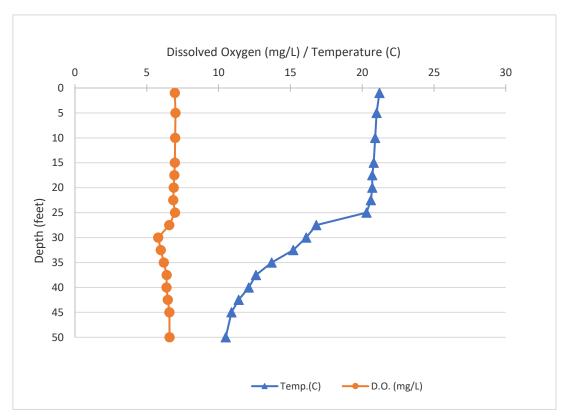
County: Mecosta Site ID: 540085 Date: 9/16/2021

Depth (ft)	Temp.(C)	D.O. (mg/L)
1	21.2	6.95
5	21	7
10	20.9	6.98
15	20.8	6.96
17.5	20.7	6.92
20	20.7	6.88
22.5	20.6	6.84
25	20.3	6.97
27.5	16.8	6.56
30	16.1	5.8
32.5	15.2	5.97
35	13.7	6.19
37.5	12.6	6.39
40	12.1	6.37
42.5	11.4	6.47
45	10.9	6.58
50	10.5	6.59
